Verification of the Effectiveness of ELCID on a Hydrogenerator Stator Core

The opportunity to carry out a study was presented by a hydrogenerator rewind scheduled to be carried out at the Woodleaf Generating Station in California in September 1997. The machine owner, the rewind contractor and the EL CID manufacturer co-operated to include a comparative study of core test methods into the routine tests performed as part of the rewind schedule.

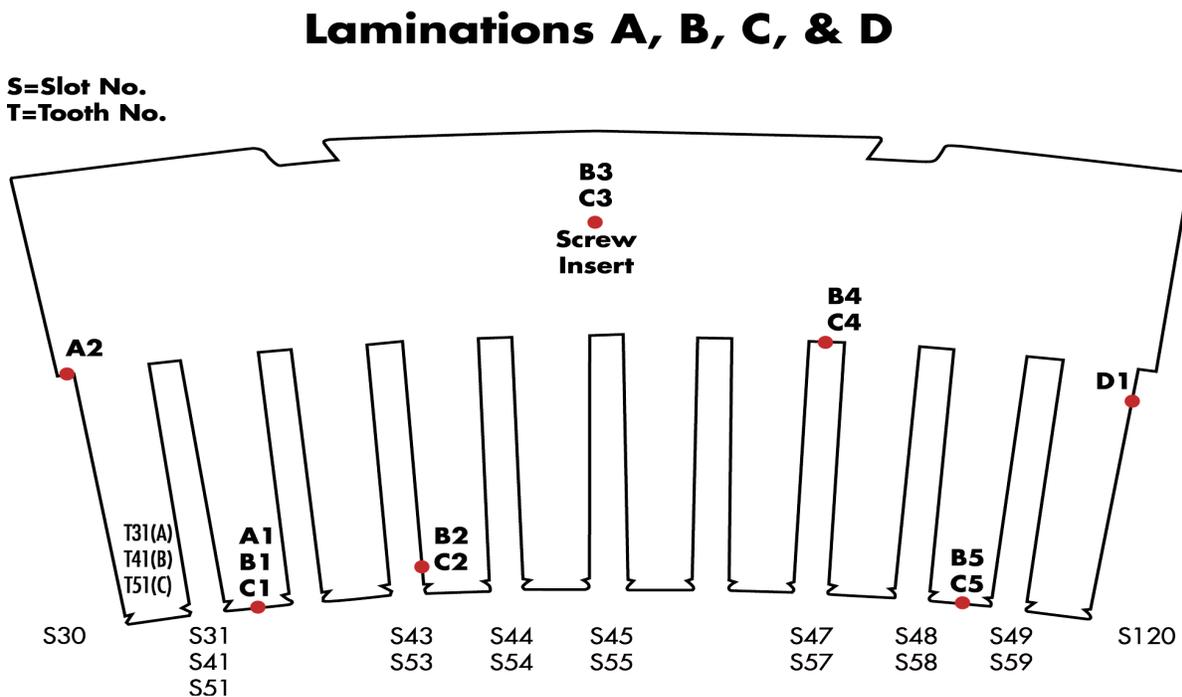
Figure 1. Location Template for Artificial Faults

The artificial faults were made within the top four inches of the core for around half its circumference between the two core splits, corresponding to slots numbered from 30 to 120, there being 180 slots in total. The main laminations of the core were in segments

of ten teeth, providing nine full slots and two half slots. Four lamination segments identified as A B C (slots 30 to 60) and D (slots 110 to 120) were used for the faults. Fault positions were selected on the tooth top surface and also on the side walls and bottom of both normal slots and slots on splits, with further faults in the back iron at the top outside end.

Most faults were produced by spot welds (of then currently unknown effectiveness). Fault D1 was made by screw compression of a short copper strip into the laminations on the tooth wall of slot 120 and faults B3 and C3 screwed into the back iron of the top surface of the core behind slots 45 and 55. Table B shows the location of the faults by slot number.

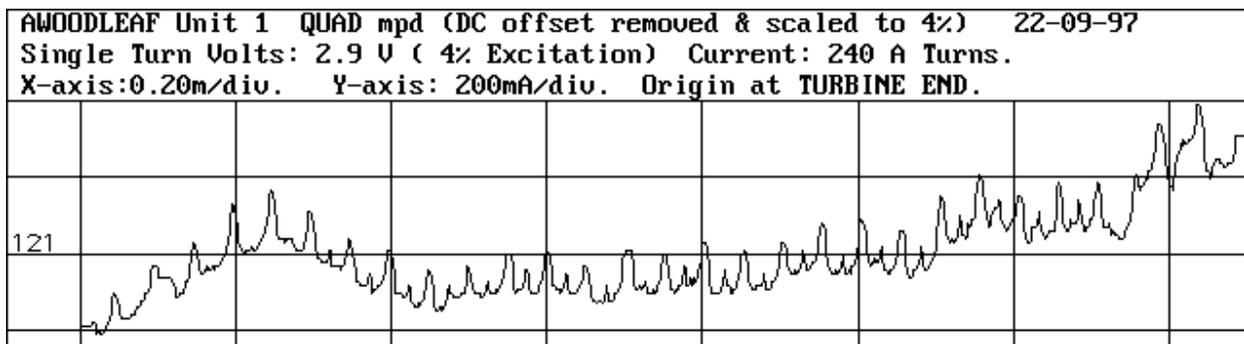
Figure 2: Flux disturbance associated with cooling ducts.

Subsequent evaluation of the test results indicated that traces for slots adjacent to the split slot would have been improved by resetting the phase on these slots also, precluded in this instance by time constraints. This would be expected to reduce the effect of perturbations in the flux such as those associated with cooling ducts, plainly visible as regular signals on some traces (e.g. slot 121 in fig 2).

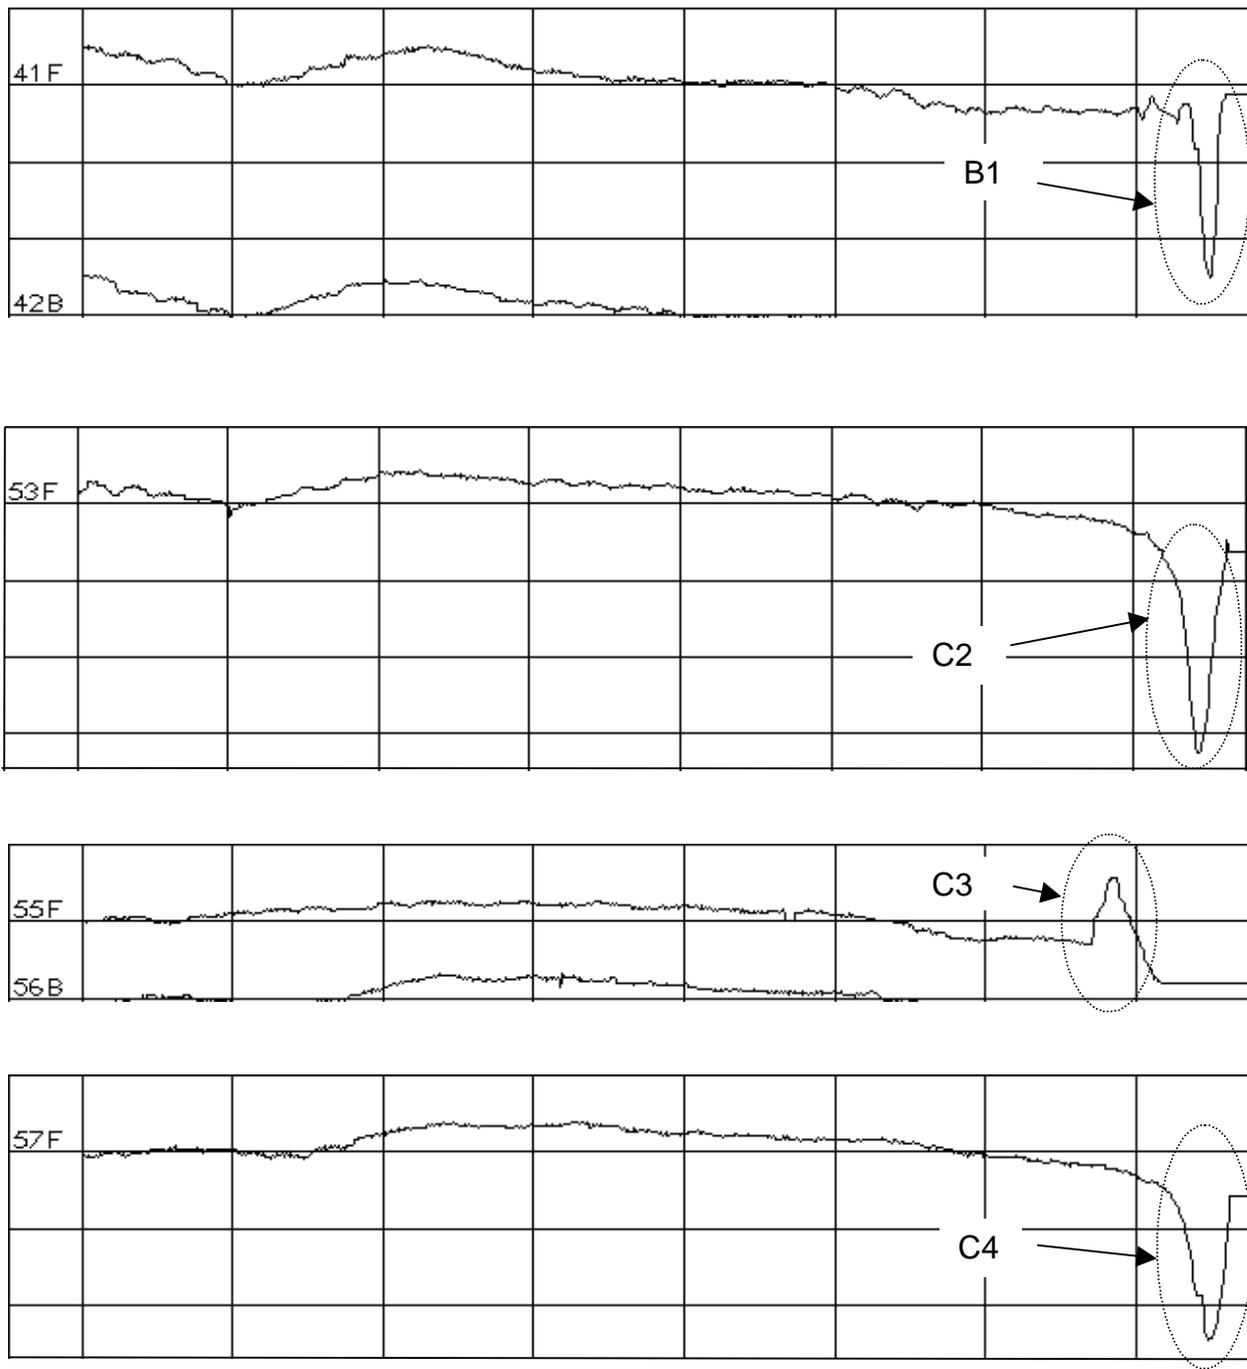
Figure 3: Indications for Artificial Faults B1,C2, C3, and C4

A table of signal responses for the artificial faults is included in Table C. Although with more time available for the test the opportunity may have been taken to repeat some traces which appear truncated or to have spurious noise effects preventing easy recognition, most faults have indications close to or exceeding the standard threshold level of 100 mA normally taken as warranting further investigation. Exceptions are surface fault C5, where incomplete traces provided little signal above noise, and B3 where a 75 mA signal was not readily discernible above noise. The presence of stator bars over the sub surface faults on B did not appear to affect detection compared with segment C, although some of the traces were less satisfactory for other reasons.

Figure 3 demonstrates typical signals from the different artificial types of fault B1, C2, C3 and C4.

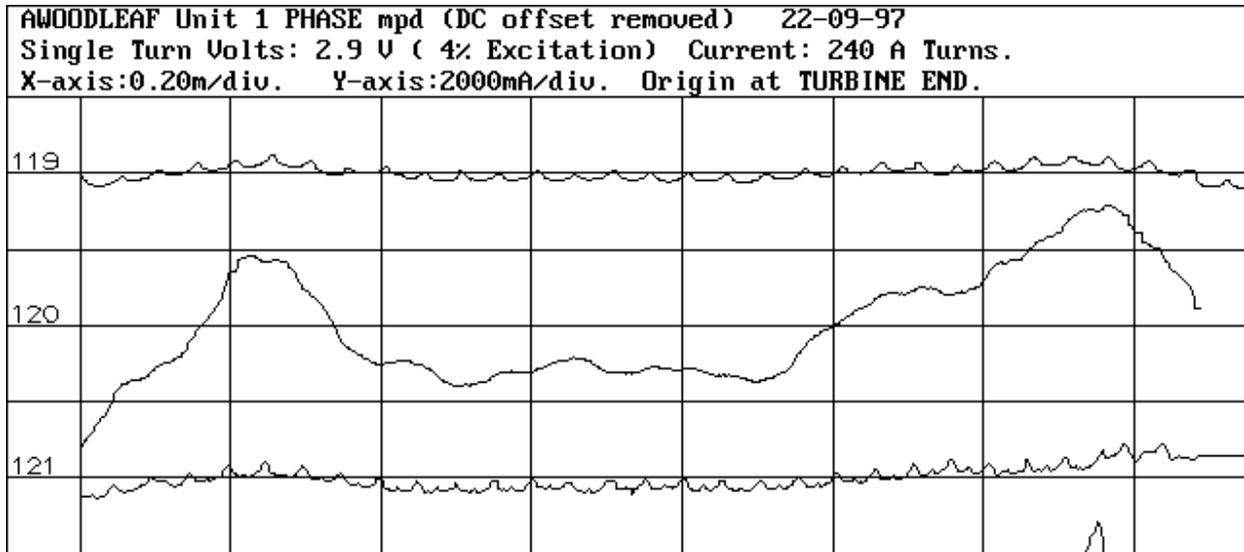
Figure 4: High Phase Signal in Region of Split

Core splits were at the bottom of slots and the excitation flux across the gaps at these splits resulted in the usual high magnetic potential and leakage flux in these regions. During the course of a normal EL CID test the Chattock sensing coil will bridge the split and consequently measure this very high level excitation signal. The excitation flux in the area of the core split will be composed of flux flowing circumferentially in the iron and that in fringe fields within the bore, not necessarily of the same phase. Any variation in the phase of the signal with respect to the reference phase will therefore produce a significant unwanted quadrature component providing spurious high background indications in the associated QUAD readings.

Figures 4 and 5 of slot 120 shows the very high magnetic potential across the core split in this slot (PHASE trace) together with the associated unusable QUAD trace from the initial Global test. It may be seen that the QUAD signal follows that of the PHASE signal (i.e., consistent P/Q ratio).

In order to reduce this effect it is therefore desirable to re-define the reference phase angle to that of the excitation flux across the split. The PHASE ANGLE RESET facility of the EL CID 601 instrument was therefore used to modify the reference phase angle of the EL CID discriminator to that of the flux in the region of the split for this purpose. Resetting of the reference phase was carried out with the Chattock sense coil across the core split at a position along the slot where fairly constant readings along the core were obtained. Auxiliary traces were then taken at the split slots. The EL CID SPU indicated that the change of phase of the excitation flux at the core splits compared with the central core was approximately 25°.

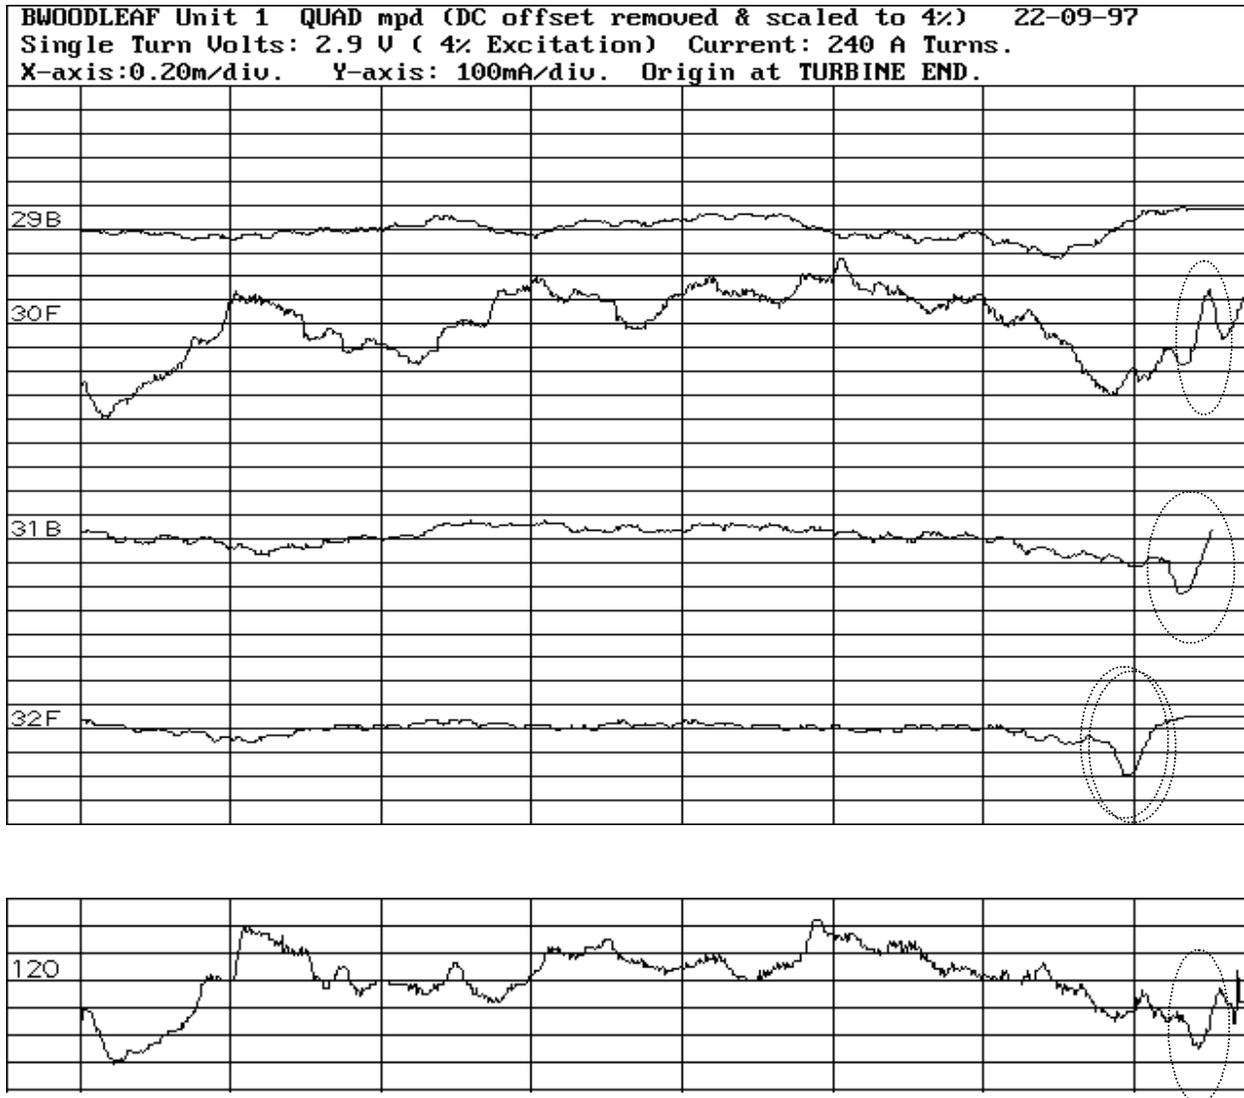
Figure 6: QUAD Signals on Splits after Phase Reset at Split

QUAD traces obtained after reset of the reference angle of the Phase Reference are shown for slot 120 in Figure 6, together with that of slot 30. Differences between PHASE signal traces before and after resetting the reference phase are not readily discernable. However, the effect of phase distortion of the high PHASE signal is still present on the QUAD traces but much reduced. Although sufficient rejection has not been obtained, the fault signals are discernible against other spurious signals of similar amplitude. Improved rejection of the phase signal is necessary for fault signals of this level but major faults would be more readily identifiable.

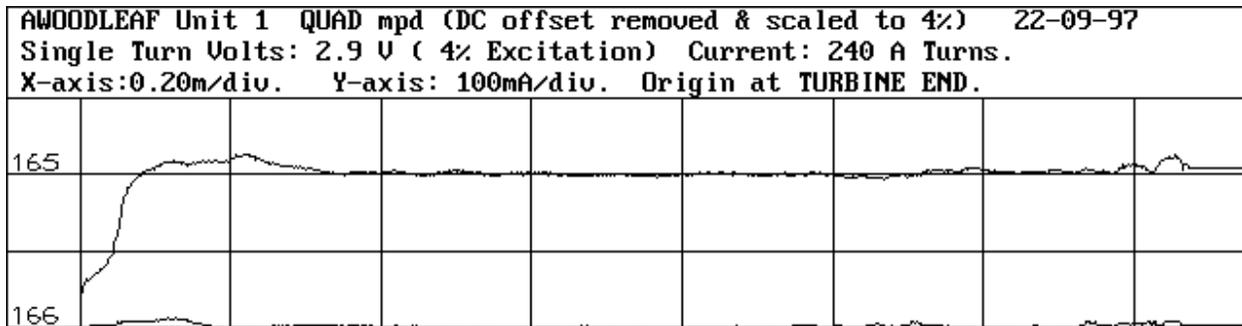
Figure 7: Non-Artificial Fault Indication

The test traces were also examined for indications of possible damage in areas where faults had not been inserted. The largest indication is at the beginning (lower end) of slot 165. Signal level is 150 mA for the initial 7 cms, rapidly reducing to zero on this slot, but not present either side. This non-artificial fault signal is included in Table C also.

Figure 7 shows the abnormal QUAD signal at the beginning of slot 165.

These signals would normally warrant closer inspection of the core including use of normal EL CID local test procedures with a miniature Chattock coil, or time permitting, careful repeat of these traces.

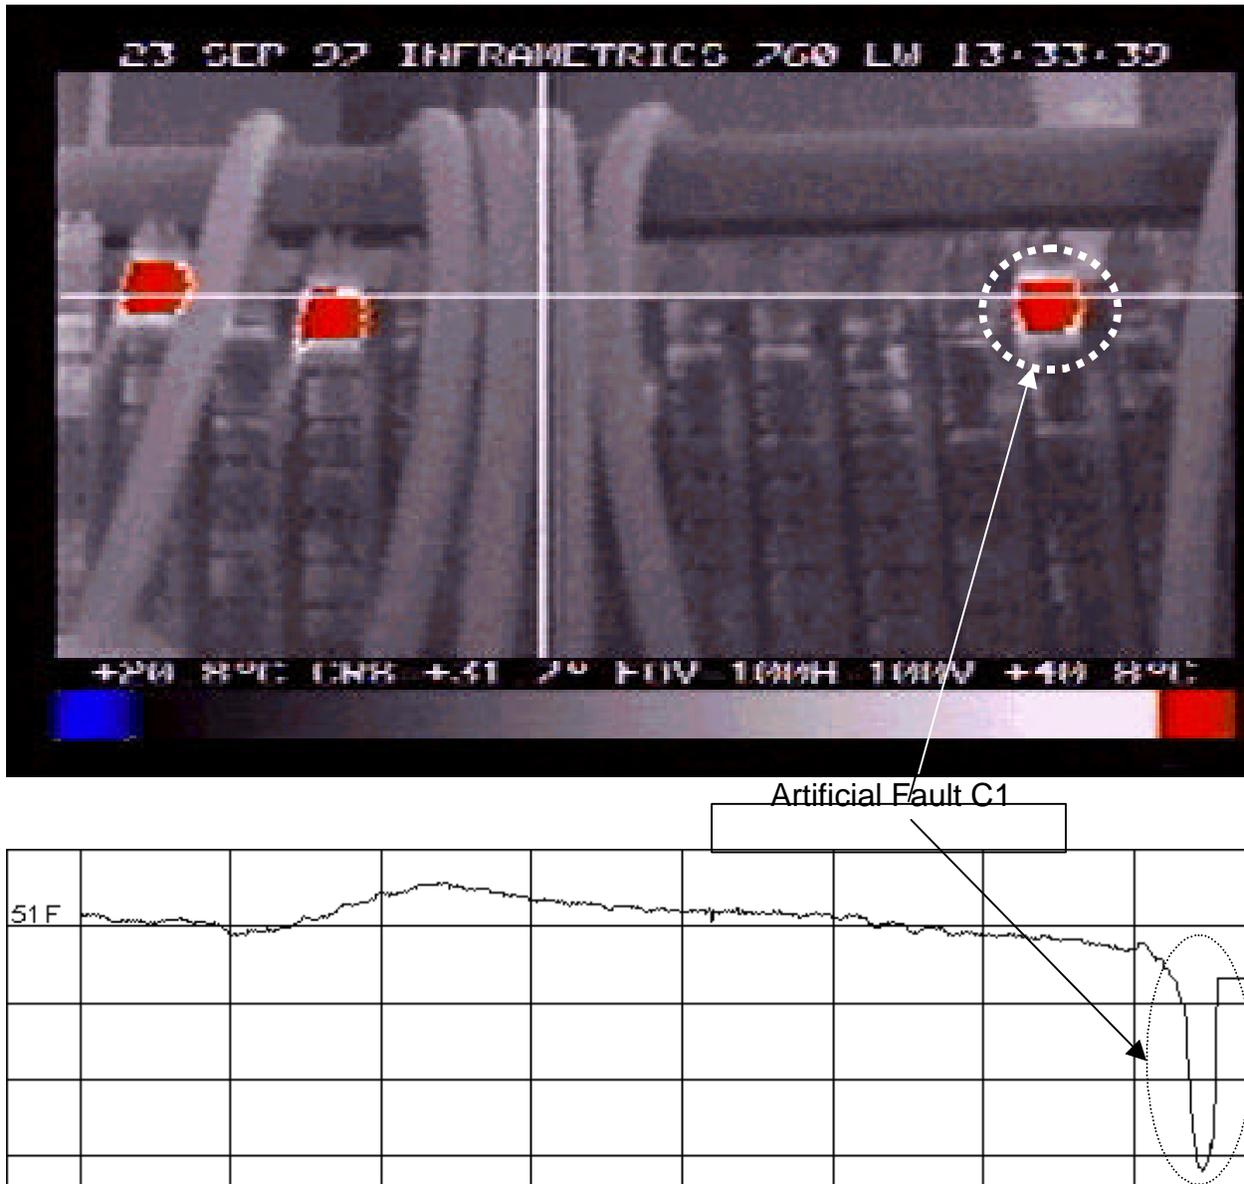
Figure 8: Correlation of Artificial Fault C1 at Tooth Tip 51/52

The correlation obtained from the artificial faults between the two test methods is shown in Table C. Severity of faults indicated from the EL CID tests is in most cases sufficiently high to provide positive indication, including that from the existing damaged area at the base of slot 165. Figures 8 and 9 illustrate the comparative indications of both tests for artificial and non-artificial faults respectively.

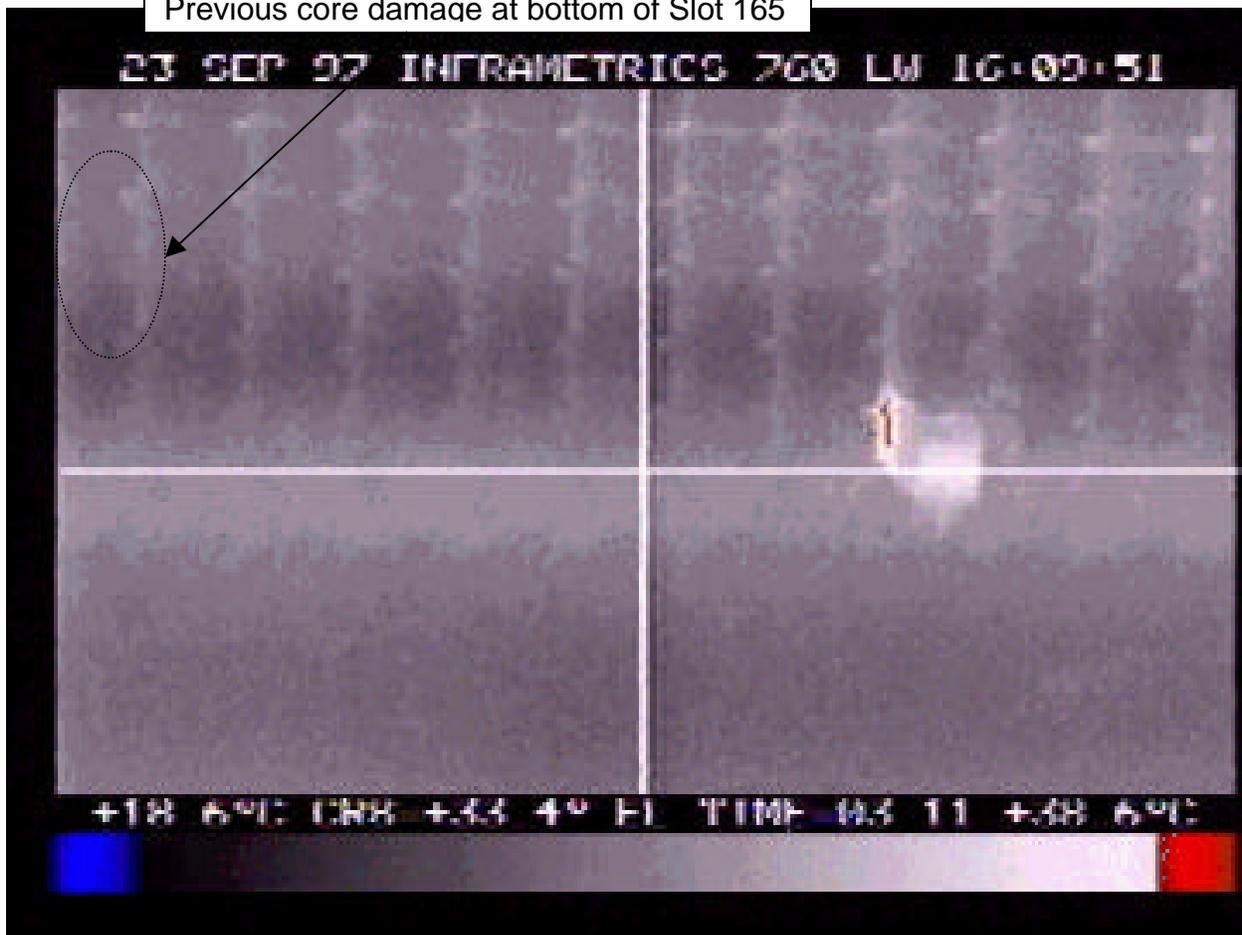
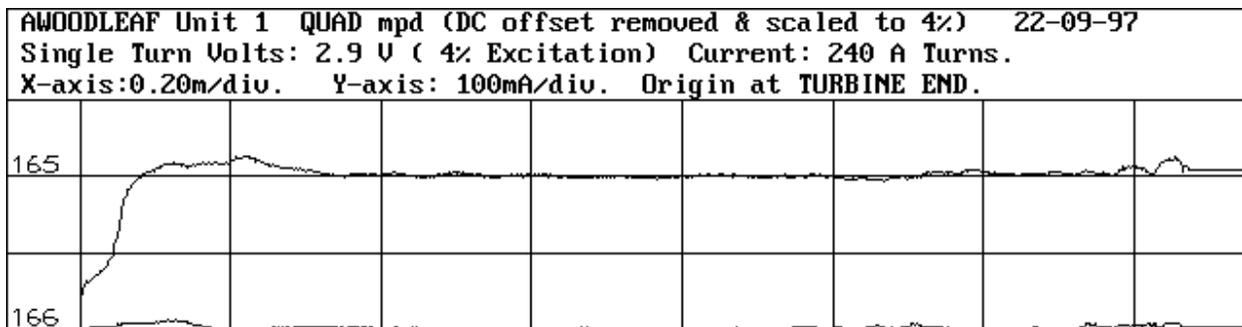
Figure 9: Correlation of Non Artificial Fault C1 at Slot 165

Previous core damage at bottom of Slot 165
