## **EXPERIENCE AND BENEFIT OF USING EL-CID FOR TURBINE-GENERATORS**

Electric Power Research Institute  
Motor & Generator Predictive Maintenance & Refurbishment Conference  
Orlando, Florida  
November 28-30, 1995

G. Klempner  
Ontario Hydro

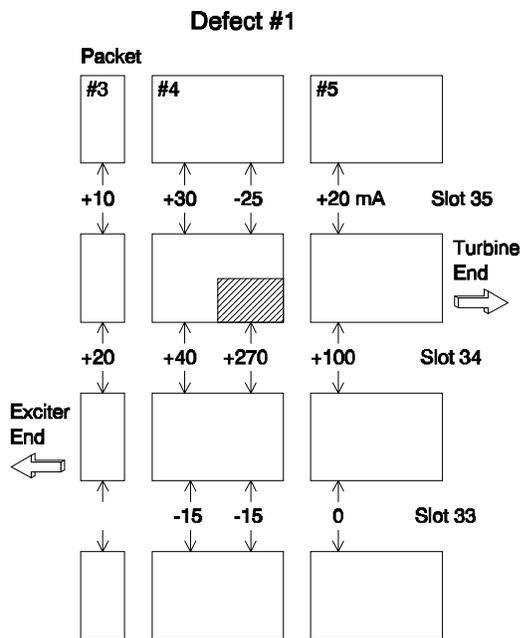
Figure 7

The first indication was located on the 3rd core packet in from the exciter end of the generator, on the tooth between slots 34 and 35. Since the reading across slot 34 was high at +270 mA, and

the reading across slot 35 was near normal, it was estimated that the fault was at or near the top of the tooth, on the side nearest slot 34. See Figure 7.

The faults were estimated to be near the top of the tooth by local scanning with El-CID flex head probes and over a substantial portion of the tooth top. In addition, the same measurements above were made in the “Phase” mode of the El-CID signal processing unit and showed levels no higher than the M.P.D. due to excitation. Therefore, it was estimated that the damage found was likely due to insulation deterioration rather than solid interlaminar iron damage. As stated previously, iron damage has been found to produce “Phase” readings over the fault area, several times the M.P.D. level.

Although significant El-CID signal levels were recorded, both defect locations did not show any visible signs of damage. Therefore, to verify the existence of the defects, a Flux test with infra-red scan was also performed.

Repair of both faults were carried out by localized grinding down of the tooth tops of both core packets by approximately 1/4". The tooth tops were then electro-etched with a 20% phosphoric acid solution to ensure separation of the laminations and that insulation could be detected to remain between all adjacent laminations on the tooth.

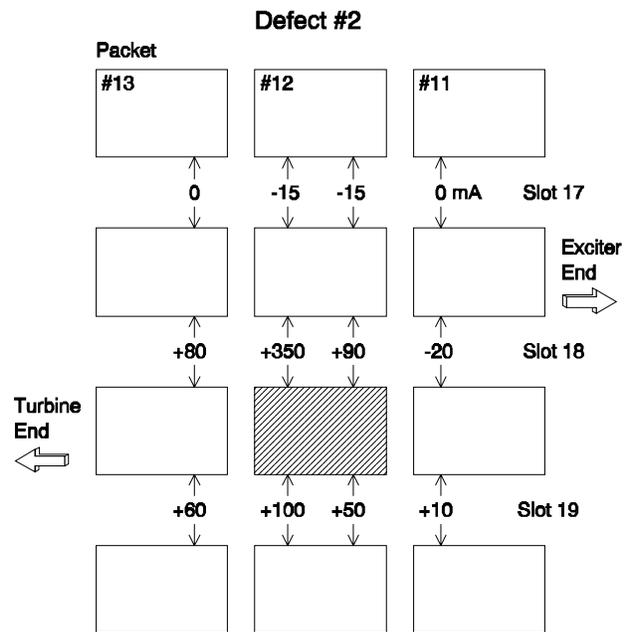
Figure 8

The second indication was located on the 12th core packet in from the exciter end of the generator, on the tooth between slots 18 and 19. The reading across slot 18 was high at +350 mA. The reading across slot 19 was also high at +100 mA but was near normal across slot 17. Therefore, it was estimated that the fault was at or near the top of the tooth between slots 18 and 19, but more on the slot 18 side of the tooth. See Figure 8.

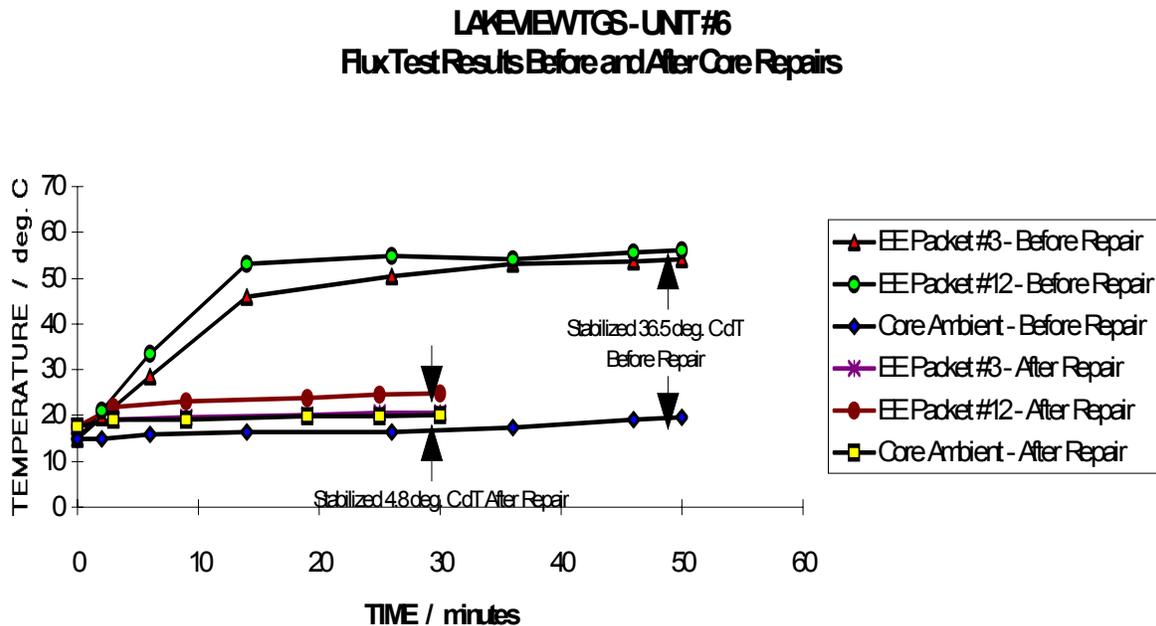
Figure 9

The Flux test was performed over a 50 minute period and indeed confirmed the presence and location of the two defects found by EI-CID testing.

The first defect on the 3rd core tooth packet between slots 34 and 35 produced a temperature rise of 33.8°C above core ambient at 15 minutes into the test. The fault temperature then stabilized to a constant temperature rise of 34.5°C above core ambient for the remainder of the test. The fact that the hot spot showed up immediately and produced a rapid rise time and stabilization, supported the EI-CID conclusion that the fault was near the iron surface. See Figure 9.

The second defect on the 12th core tooth packet between slots 18 and 19 produced a stabilized temperature rise of 36.5°C above core ambient also by approximately 15 minutes into the test. The fault temperature remained fairly stabilized at this level above core ambient for the remainder of the test. Again, the fact that the hot spot showed up immediately and produced a rapid rise time and stabilization, supported the EI-CID conclusion that the fault was near the iron surface. See Figure 9.

A second EI-CID test (at identical excitation levels) was performed, which produced signal levels over the fault areas of no more than 40 mA. A successful repair was indicated.

To further confirm the repairs and verify the EI-CID results, a second Flux test (also at identical excitation levels) was performed. The Flux test showed temperature rises on both fault locations of now only 4.8°C after 30 minutes. See Figure 9. Therefore, Ontario Hydro's criteria of no hot spots above 5°C was met and the damage to the stator iron was considered repaired.

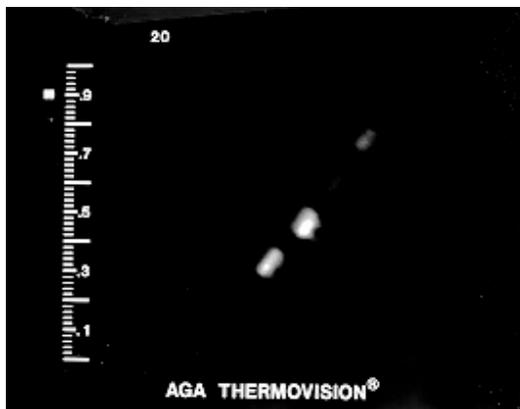
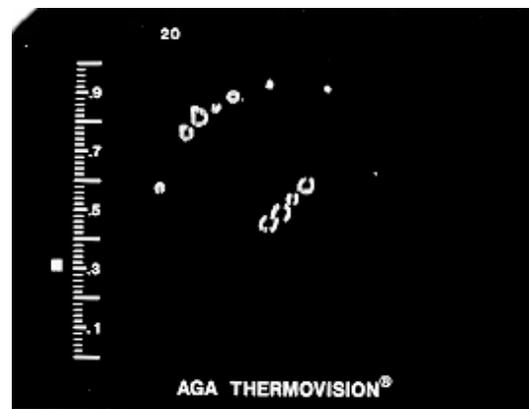
#### Thermography of the Defects on Nanticoke TGS Stator #4301

After a winding failure on this stator in August 1989 and an inspection of the stator iron, it was noticed that there were a number of 1st packets on the exciter end of the stator, around the bore circumference, that had visible damage. The core iron was found to be loose on a number of these 1st packets at the core end, and the insulation obviously worn away on some. An EI-CID test confirmed the damage in the areas indicated, but that the rest of the core was found defect free.

To determine the severity of the damage, a Flux test was also done to compare results. In fact, the Flux test results verified the location of the faults and that the remainder of the core was indeed free of damage. Figure 10 shows a thermographic close-up view, in the rotating mirror, of some of the worst defects. Figure 11 is an isotherm view of a number of defects, viewed both directly on the core end and of their image in the mirror.

The core damage was then repaired by inserting thin pieces of mica between the loose laminations, soaking the area with a penetrating/insulating epoxy and then re-tightening by driving a 1/16" G10 glass stemming piece radially into the center of the 1st core packet. See Figure 13. The result was the re-establishment of insulation between core laminations and tightening of the core end iron to reduce the possibility of further fretting in service.

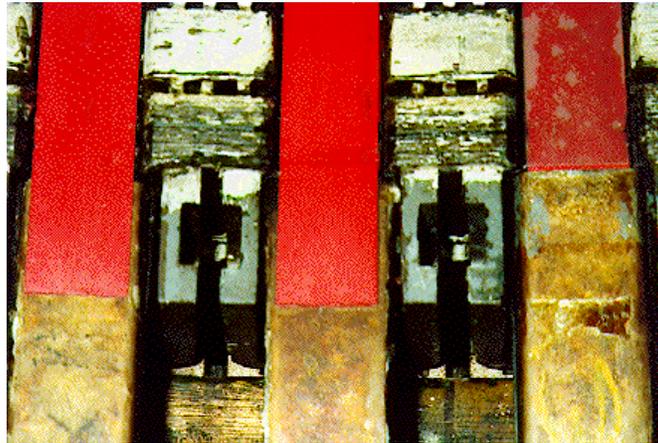
Figure 13

#### Repaired Damage at the Exciter End of the Core - 1st Packets

The repairs made were extensive and were the best that could be done without very expensive restacking of the stator core. The core tightness on the teeth was re-established as best as possible but was and is still regarded as a local repair and is not considered a substitute for re-pressing of the core.

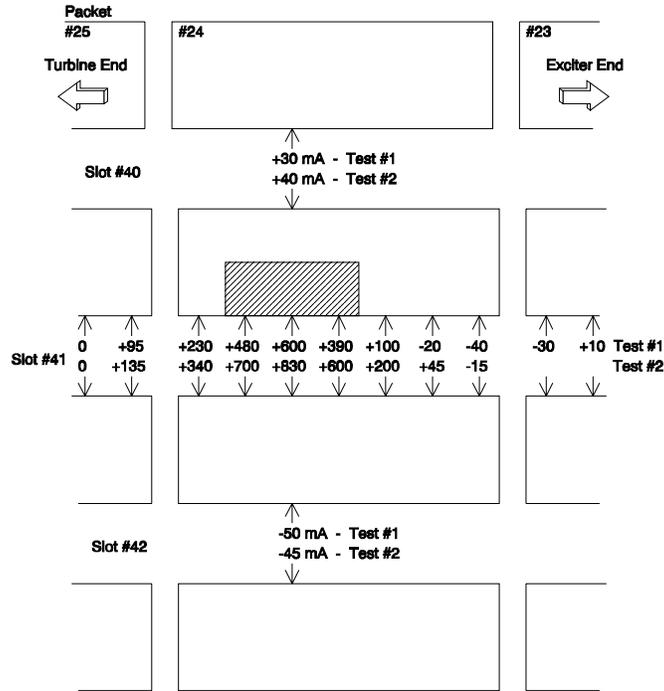
The defect signal was found to be across slot 41 on the 24th core packet in from the exciter end of the generator. A complete EI-CID signal profile of the fault area was made and is shown in Figure 14. The significant points to notice on the fault map are the low readings across slots 40 and 42 which tend to indicate that the fault is deeper down in the slot. In addition, the signal across slot 40 is the same polarity as the main defect signal while the signal across slot 42 is the opposite polarity. This suggests that the defect is most likely on the side of the tooth in slot 41, but on the tooth adjacent to slot 40.

However, the defect location across slot 41, on packet 24 in from the exciter end of the machine, now recorded an increased EI-CID signal level to +830 mA in the exact location of the original that was found to be +600 mA. All other adjacent readings increased as well. See Figure 14 above.

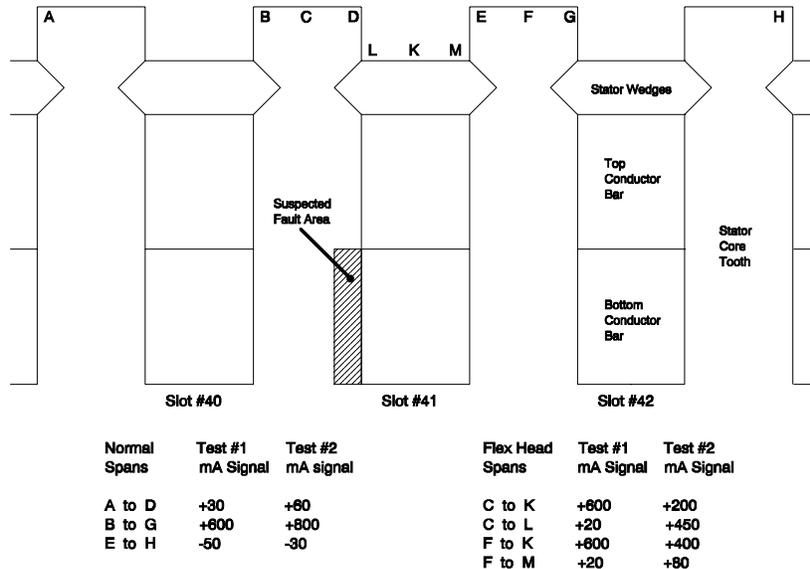
Additional readings were taken with a smaller EI-CID flex head probe to try to determine the depth of the fault. Figure 15 is a map of the readings taken and the results. The significance of these results are that the readings also tend to indicate that the fault is not near the top of the stator tooth but rather farther down the slot. It is our speculation that the fault is most likely near the bottom of the slot next to the bottom conductor bar.

Additional readings were again taken with a smaller El-CID flex head probe to fully characterize the fault. Figure 15 above also shows the results of this second test. The signals recorded were now higher in the more localized shorter measurement spans. The significance of this is uncertain but it was thought at the time that the insulation now may be becoming heat affected, causing the interlaminar insulation near the fault to be deteriorated over a larger surface area. Speculation was still high that the main fault is near the bottom of the slot next to the bottom conductor bar.

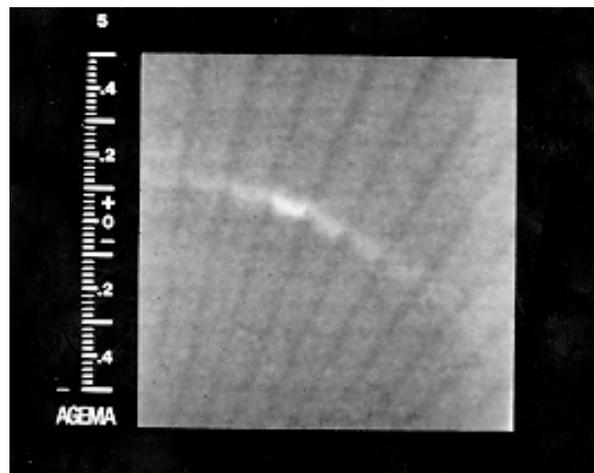
Figure 16

Since the generator was fairly new, there was considerable concern that the EI-CID test may not be correct. Therefore, a 75% rated Flux test was done and the core scanned for hot spots with an Agema infra-red system. The defect location was confirmed and is shown in a thermographic view in Figure 16.

The Flux test produced a very slowly rising ambient core temperature and a very slow rising fault temperature that only reached 5°C above the rest of the core after one hour. The test was run for an additional 2 hours and the temperature rise only reached 8°C above the rest of the core. This type of information tends to confirm that the defect is likely deeper in the slot, relatively small, highly localized, and probably in the infant stages. Therefore, the unit was returned to service with the intent to inspect again in about three years.
