Presented at Latin America Power 2000, Caracas, Venezuela, May 2000

Electromagnetic Core Imperfection Detection (ELCID) A Collection of Case Studies

Brad McNamara, P.Eng.
ADWEL International Ltd.

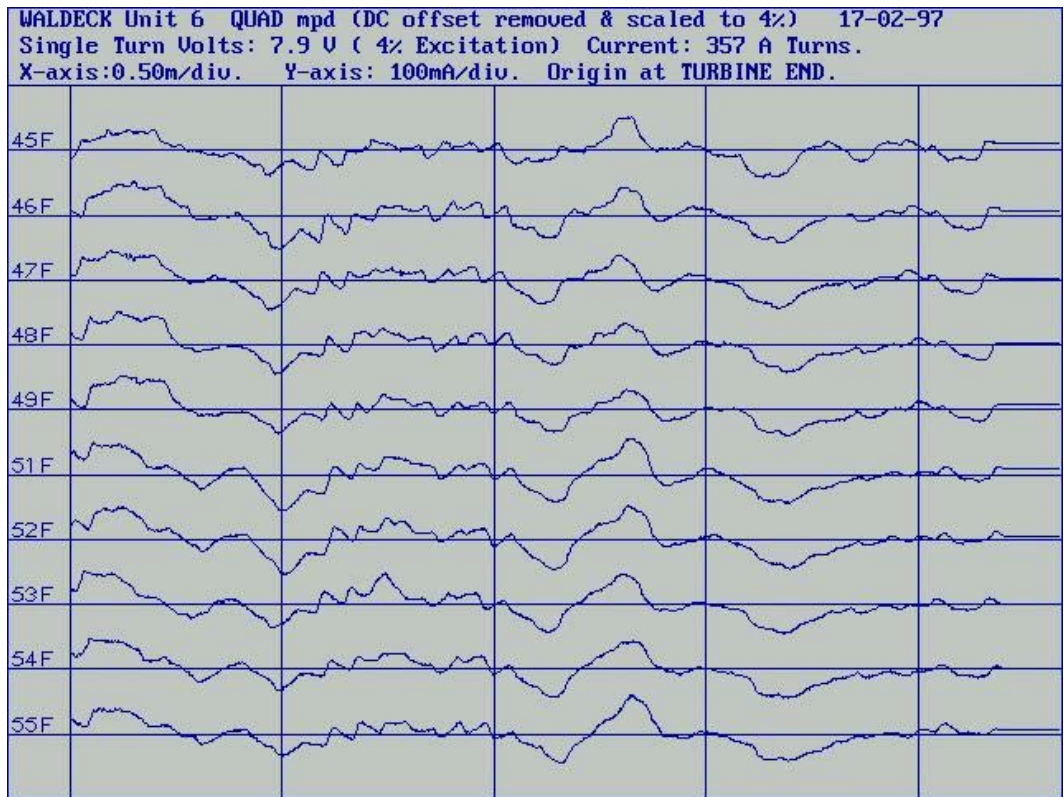
Two 12 hr. shifts were required to complete the test. Results were unambiguous and showed that no serious faults existed. Figure 13 show a sample of the results collected.

Figure 13. Sample ELCID results from Waldeck

The core was eventually removed and tested with both ELCID and high-powered loop test to verify the results. The ELCID results were very reproducible. The loop test showed no serious problems but highlighted a number of short faults, which gave a temperature rise of 5°C above ambient. The utility chose to have some repair work done although the core could easily have been put back into service without any repairs being done.

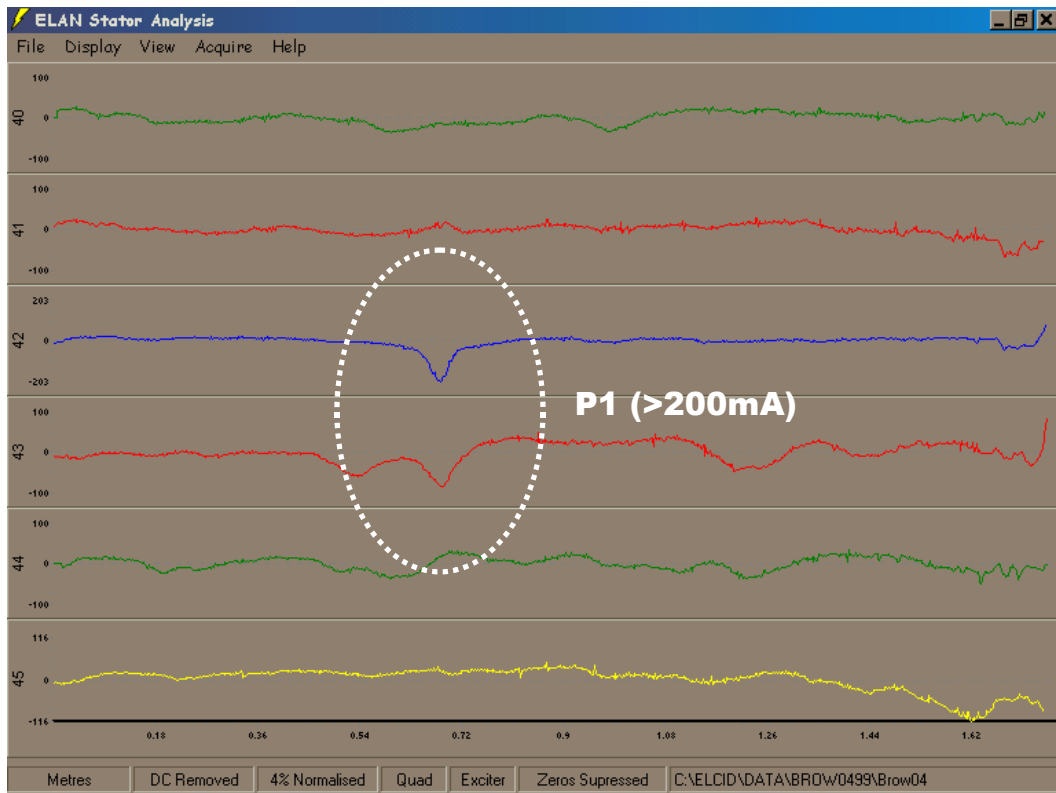
A routine ELCID test was planned to confirm the acceptable condition of the stator core. An initial ELCID global scan, however, indicated a core with numerous surface and slot faults of various magnitudes (Figure 14). A subsequent high flux test (loop test) confirmed above ambient heating as a result of slot and surface damage most likely caused by excessive bar vibration. A sample of the damaged areas and the resultant increase in core temperature is shown in Figure 15.

Figure 14. ELCID values exceeding 200mA at Point Labeled P1 (Slots 42/43)

After considerable repair efforts and one final ELCID inspection to confirm the effectiveness of repairs, the utility was able to salvage the existing stator core, install new coils, and return the unit to service.

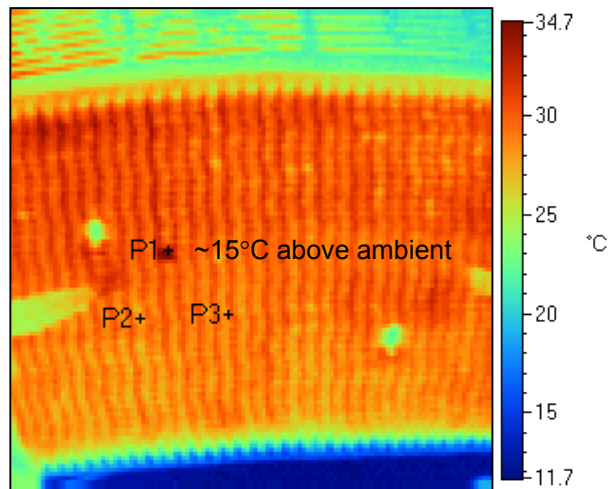
Figure 15. Loop Test result for Slot 42/43 showing >15°C temperature rise

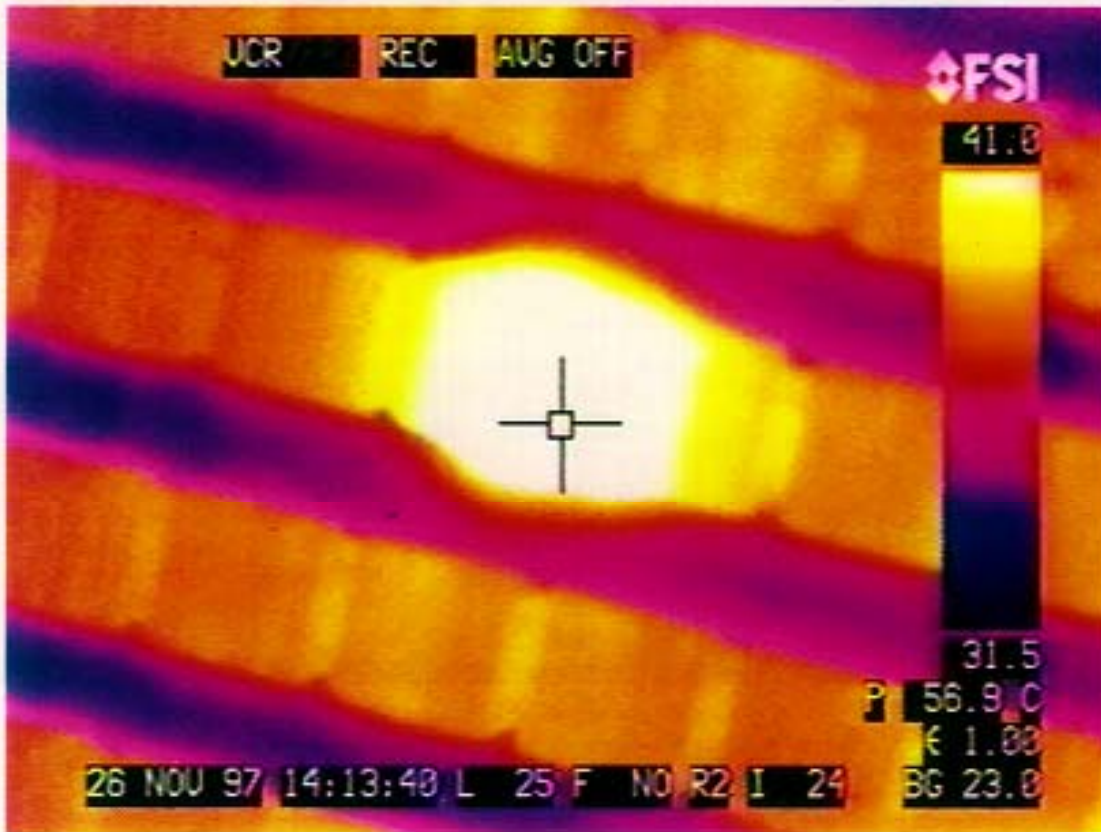
The loop test was performed one day prior to the ELCID test. The stator core was energized to a flux level of 0.835 Tesla and held for 45 to 60 minutes. Several locations were identified where the temperature was 5OC above the average core temperature. As an example, one area of slot 157 indicated a temperature rise of 15OC after 60 minutes. Figure 16 displays the thermographic image of that slot.

Figure 16. Thermographic Image for Slot 157 Damage

Based on the indications of both tests and the age of the core the customer decided to completely replace the core iron. Prior to completely removing the old core, the damaged areas were visually located. Figure 18 shows the damage found at slot 157. It was determined that the damage was caused by a coil groundwall fault which fused about 35 laminations located about 320mm from the exciter end of the core and 20mm below the core surface.

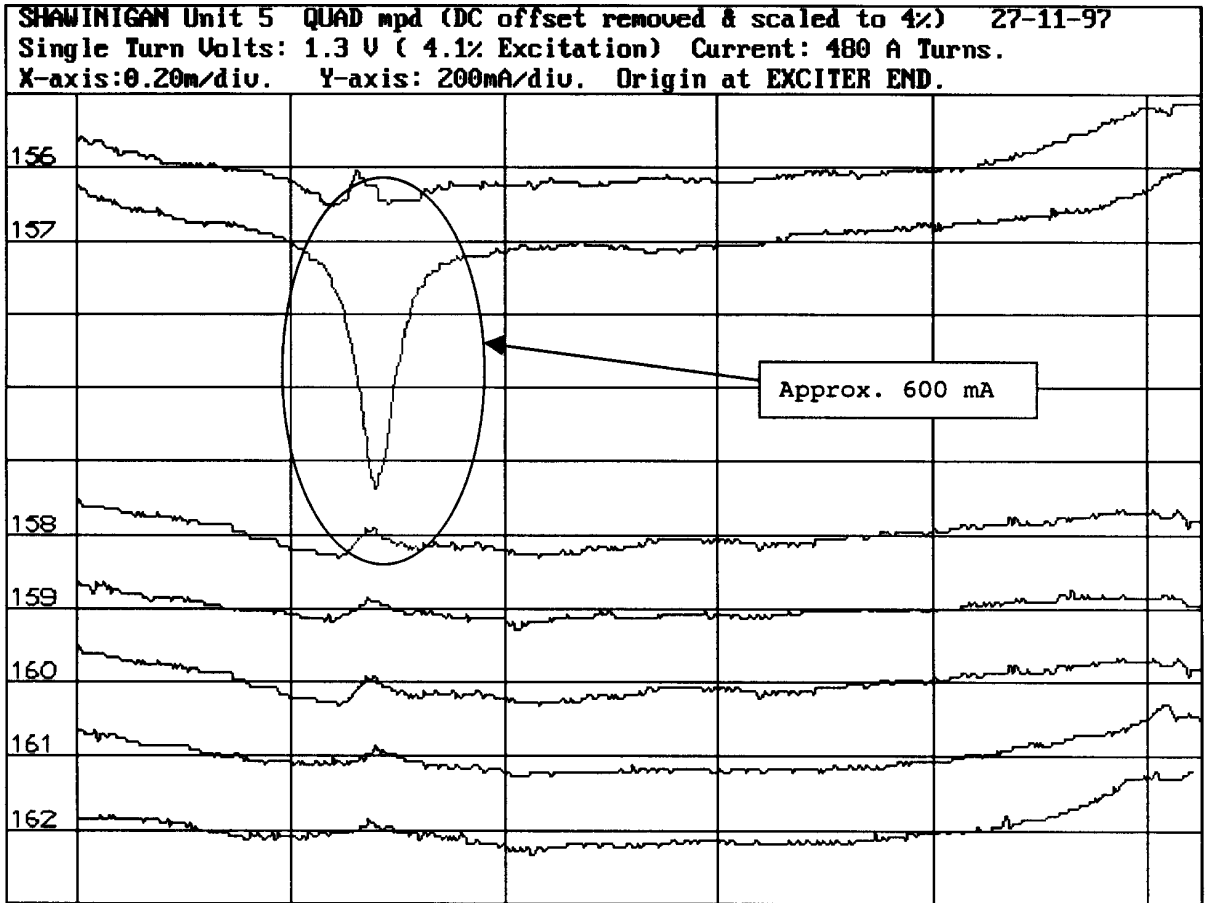
The following day an ELCID test was conducted using the Digital ELCID-Model 601. The core was energized to 4% of its rated flux density using an excitation system of 20 series connected turns of 10AWG wire and a current of 24 amps. Indications corresponding to the previously located thermal hot spots were found for each of the damaged areas. Figure 17 illustrates the ELCID trace for slot 157. The fault current indicated greatly exceeds any acceptance criteria.

Figure 17. 600mA ELCID Indication for Slot 157

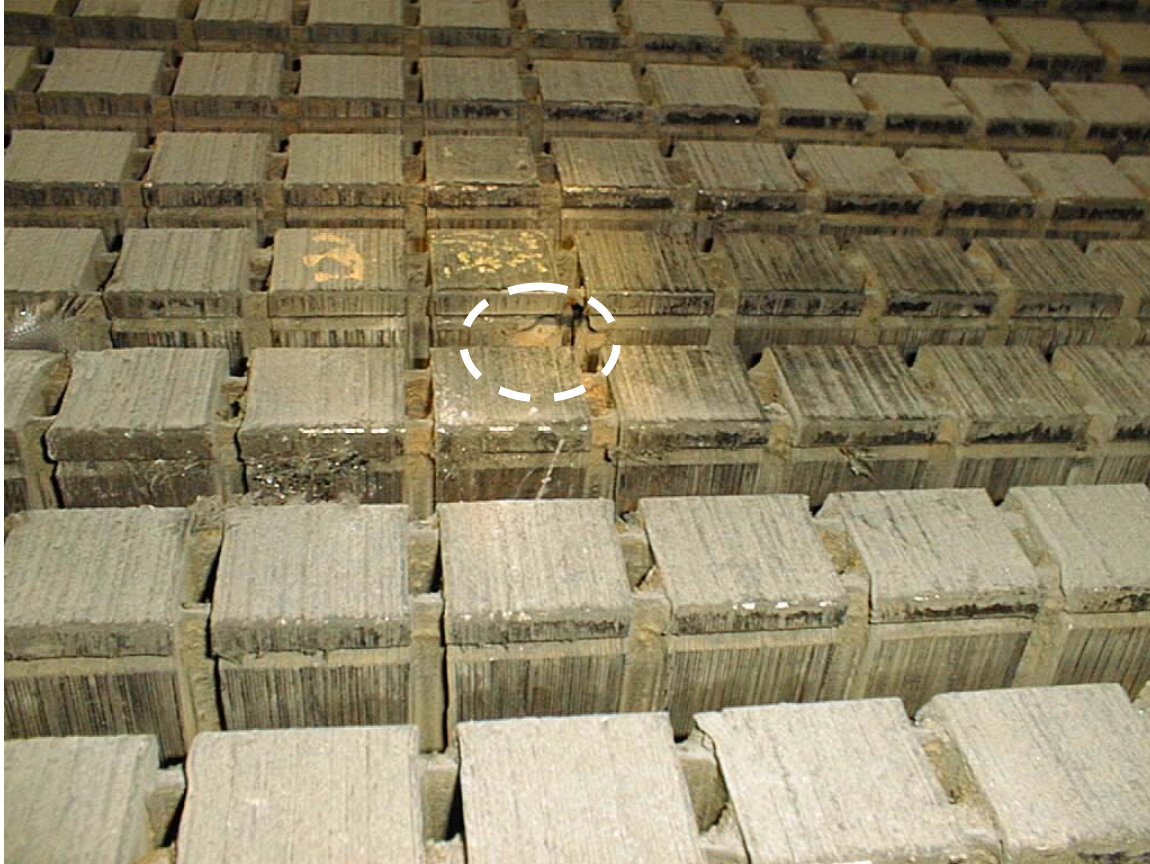
Figure 18. Visual Confirmation of Damaged Area
