## **EXPERIENCE AND BENEFIT OF USING EL-CID FOR TURBINE-GENERATORS**

Electric Power Research Institute  
Motor & Generator Predictive Maintenance & Refurbishment Conference  
Orlando, Florida  
November 28-30, 1995

G. Klempner  
Ontario Hydro

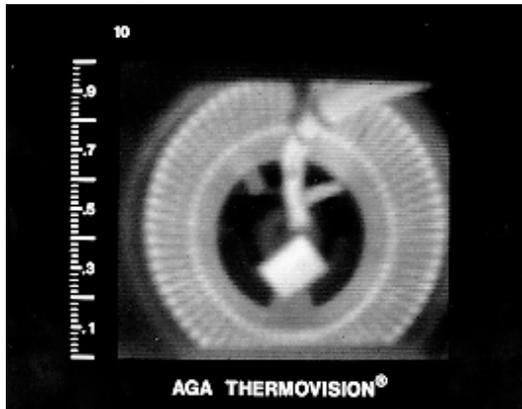
Figure 5 is a thermographic view of the bore of a four pole stator with the excitation winding and rotating mirror installed. Figure 6 shows the same view with the thermographic isothermal level now visible. The hot spot areas and general good core areas in the view are located with the infra-red system's isotherm function and the isotherm level recorded on the vertical scale at the left. The temperatures of the isothermed areas are then calculated based on the isotherm level measured, a reference measurement and the ambient air temperature. In the particular example shown here, the thermography was done by an AGA Thermovision System 750. Newer systems can now produce outputs as temperature values directly, and show the delta temperature from one area to another in varying degrees of colour.
