Presented at Latin America Power 2000, Caracas, Venezuela, May 2000

Electromagnetic Core Imperfection Detection (ELCID) A Collection of Case Studies

Brad McNamara, P.Eng.
ADWEL International Ltd.

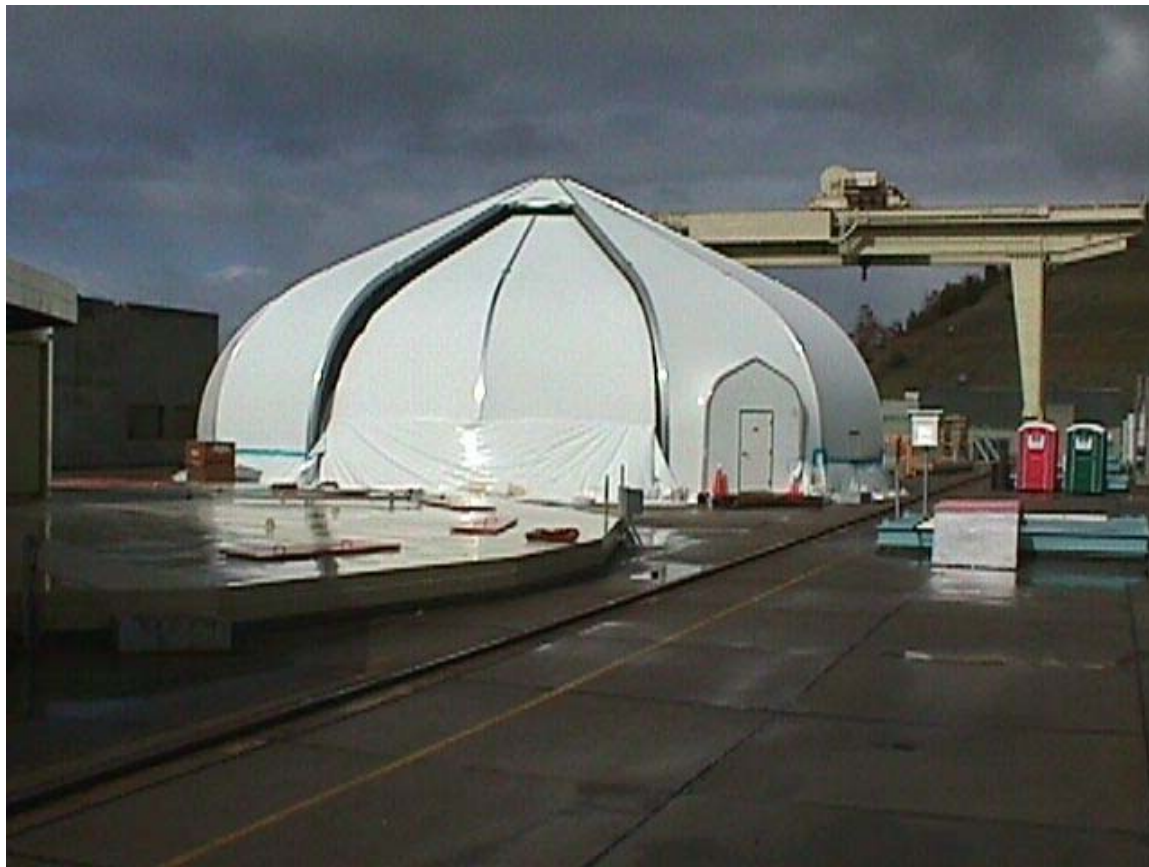
Figure 1. Exposed generator with weatherproof enclosure

All three ELCID tests indicated a stator core in acceptable condition without existing or resultant damage from the rewind process. The core was rewound and returned to service with confidence in the integrity of the existing stator core iron. Each of the three remaining sister units will undergo this same procedure in the years to come.

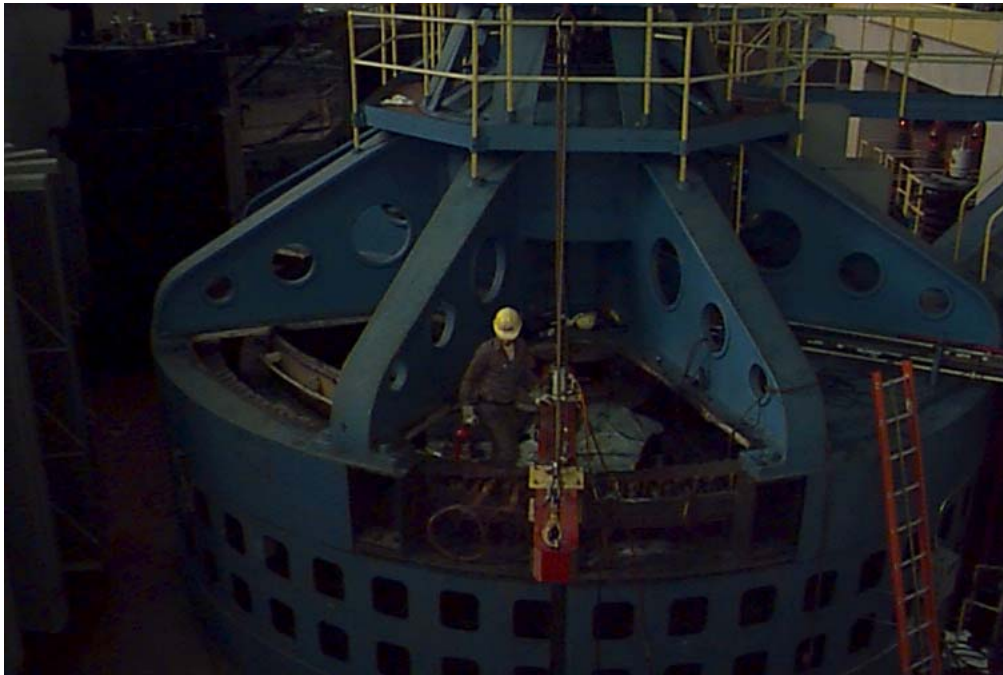
Figure 6. Unit #4 at ALCAN's Chute a Caron facility

As this was an open-air ventilated machine in operation for a number of years there was a significant build up of dirt and grease on the core's inner diameter. This, however, did not prove to be an issue for the magnetically-attached, tractor-driven robotic vehicle. Each area was scanned and the rotor indexed to the next location in less than 8 hours. It is conceivable that given sufficient time, the entire stator could be evaluated in this manner. Sufficient information was collected, however, to increase the owner's confidence in continuing to operate the machine until a more thorough investigation could be properly scheduled.

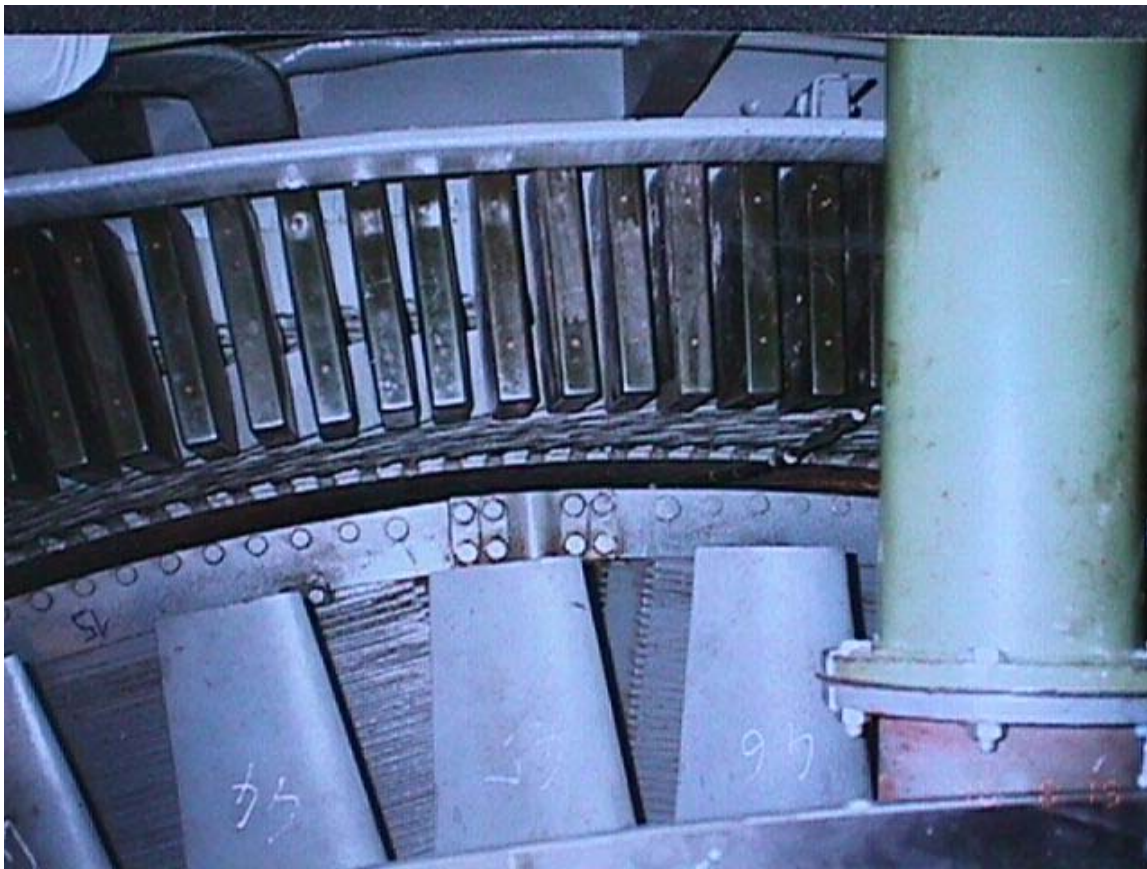
This test proved to be particularly challenging because the airgap was only 42mm (Figure 10) and at the time the only robot available had a height profile of 42mm. Access to the core was only possible from the top and due to the construction of the machine there was a restricted working area.

Figure 10. Air gap at Waldek
